Contract #: 04-0120F4Cty: SF/ALA Rte: 80 PM: 13.2/13.9File #: 1.28**WELDING INSPECTION REPORT****Resident Engineer:**Siegenthaler, Peter**Address:** 333 Burma Road**City:** Oakland, CA 94607**Report No:** WIR-024307**Date Inspected:** 07-Jun-2011**Project Name:** SAS Superstructure**OSM Arrival Time:** 700**Prime Contractor:** American Bridge/Fluor Enterprises, a JV**OSM Departure Time:** 1530**Contractor:** American Bridge/Fluor Enterprises, a JV**Location:** Job Site**CWI Name:** Steve Jensen**CWI Present:** Yes No**Inspected CWI report:** Yes No N/A**Rod Oven in Use:** Yes No N/A**Electrode to specification:** Yes No N/A**Weld Procedures Followed:** Yes No N/A**Qualified Welders:** Yes No N/A**Verified Joint Fit-up:** Yes No N/A**Approved Drawings:** Yes No N/A**Approved WPS:** Yes No N/A**Delayed / Cancelled:** Yes No N/A**Bridge No:** 34-0006**Component:** Tower**Summary of Items Observed:**

114 Meter elevation – South Tower – Splice Plates

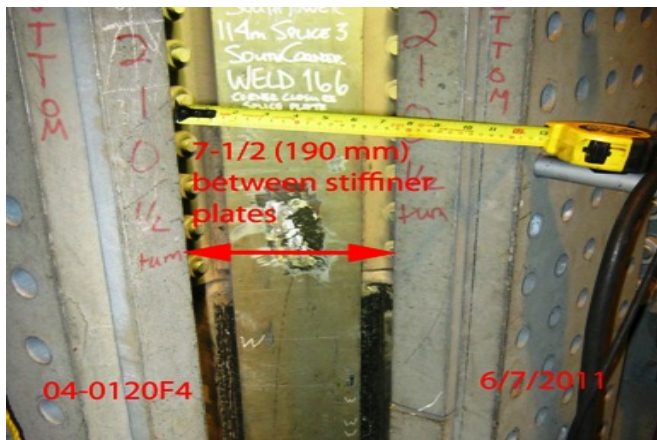
This QA Inspector made multiple trips to the location where welding was being performed above and observed QC Inspector Steve Jensen periodically monitoring the welding. See photo below of the confined space at weld #166-South, which will be the typical for each tower. The work observed by this QA Inspector appeared to comply with the contract requirements.
